Manhole Inspection Summary

Manhole # S15WW1007MH

Insp Date: **5/1/07 1:56 PM**

Location Address: **NORTHERN PKWY**

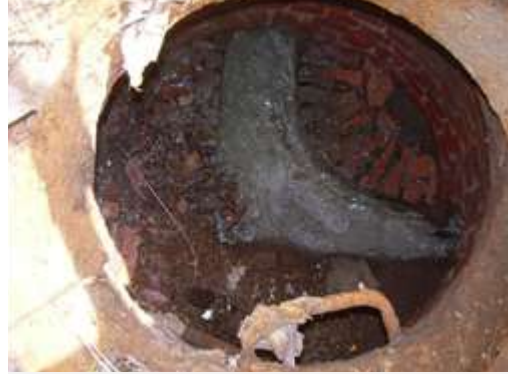
Top View

Corroded steps. Evidence of surcharge - Bench debris.

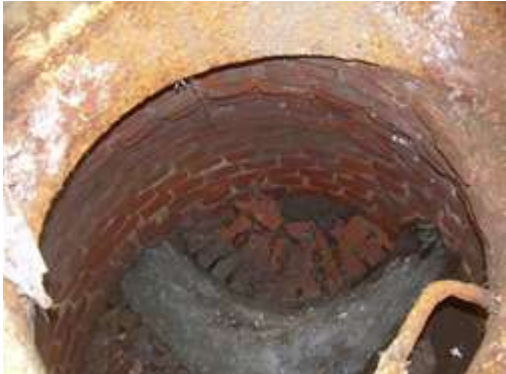
Defect

Frame leaks. Frame offset. Adjustment deterioration and infiltration. Corbel and Barrel infiltration.

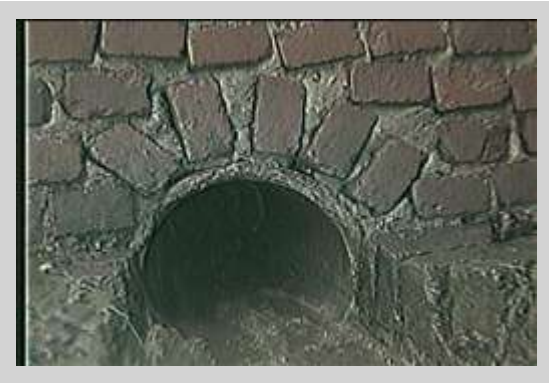
10 in. Circular Gravity Sewer Pipe Out @ 12 O'Clock

Barrel deterioration and infiltration. Channel deterioration.

Infiltration: **Evidence** Pipe Seal Cond: **Cracked**

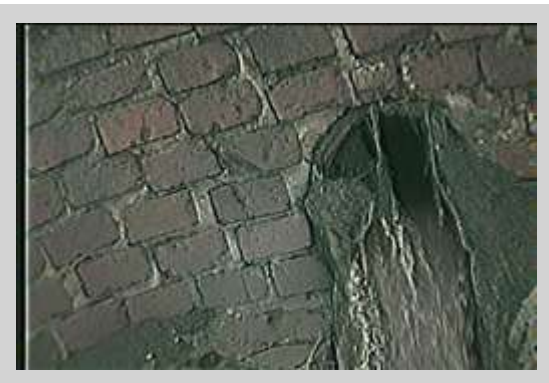
8 in. Circular Gravity Sewer Pipe In @ 3 O'Clock

Infiltration: **Evidence** Pipe Seal Cond: **Roots**
